## SHIPBOARD EXPOSURE TESTING OF AIRCRAFT MATERIALS ABOARD USS RANGER

FINAL REPORT

6. AUTHOR(S) E. TANKINS, J. KOZOL, E. LEE				
7. PERFORMING ORGANIZATION NAME(S) AND ADDRESS(ES) Air Vehicle and Crew Systems Technology Department (Code 6063) NAVAL AIR WARFARE CENTER; AIRCRAFT DIVISION, WARMINSTER P.O. Box 5152 Warminster, PA 18974-0591			8. PERFORMING ORGANIZATION REPORT NUMBER  NAWCADWAR-94019-60

13. ABSTRACT (Maximum 200 words)  <p>This report describes the results of 4 months of exposure to the Naval Environment of an aircraft carrier flight deck on a variety of aircraft materials and coatings. Test specimens included aluminum-lithium alloys, metal matrix composites, laminates and primerless paint.</p>

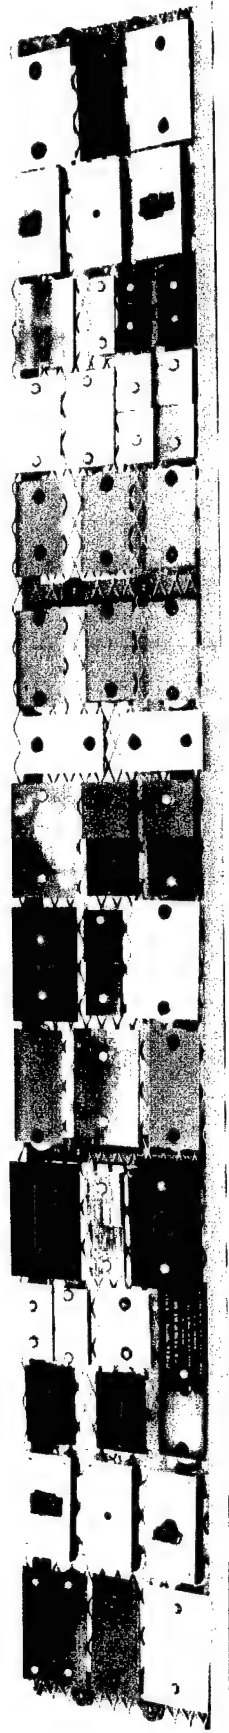
Figure 1. Test Specimens Prior To Shipboard Exposure.

The test rack prior to exposure is shown in Fig. 1. Positions on the rack are numbered from top to bottom and left to right and described in Table II. Included as test specimens were aluminum-lithium alloys (and Russian versions), high temperature and high strength aluminum alloys in various forms, aluminum metal matrix composites and aramid aluminum laminates, coated magnesium alloys and aluminum alloys with Unicoat primerless paint coatings.

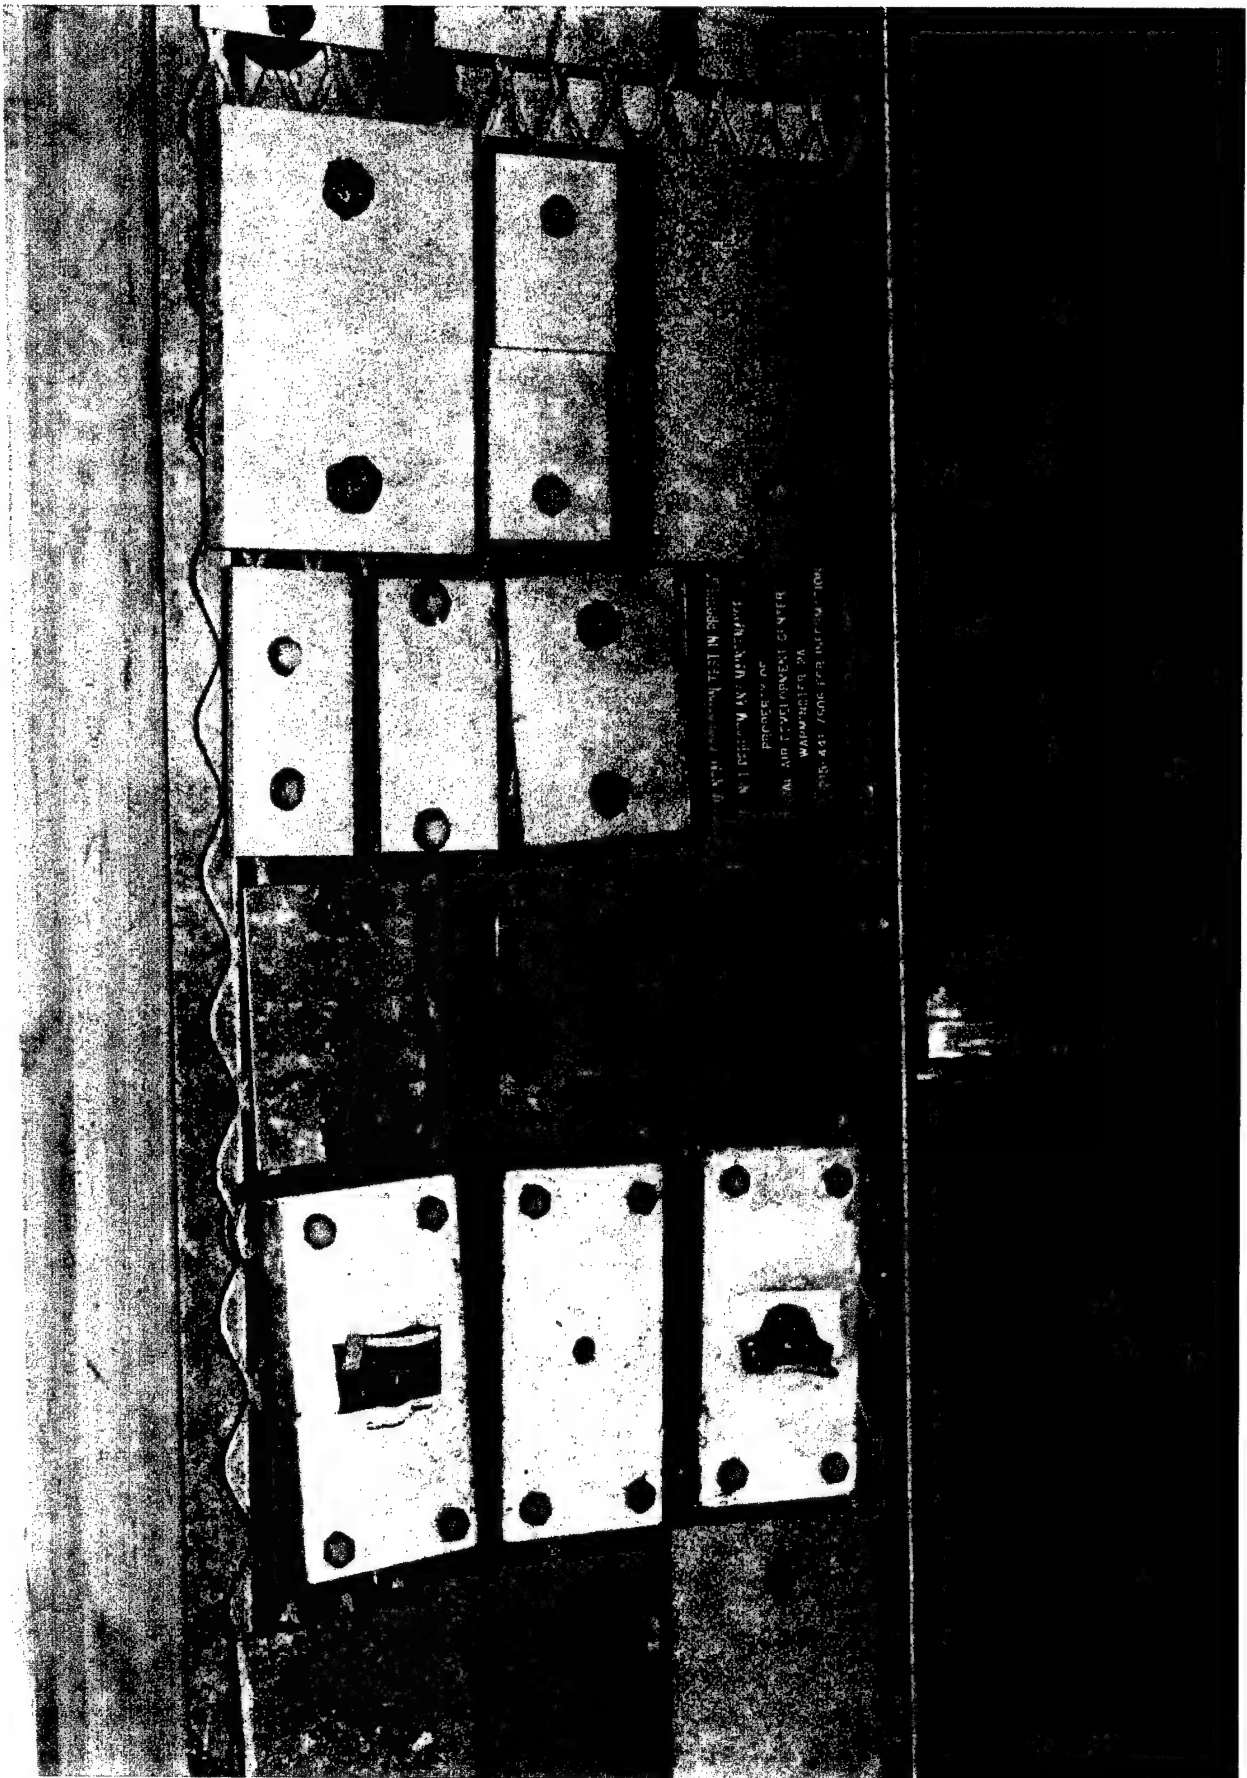
Figure 2. Left Section Of Rack After Exposure.

All shipboard exposed specimens were discolored and covered with a thin, gray film upon return. The analysis of similar films from previous exposures indicated the film consisted primarily of MIL-L-23699 engine oil deposits with some sulfur (Ref.2). Appearance of the test specimens after shipboard exposure is shown in Figures 2,3,4 for the left, center and right sections of the rack respectively. Observations of the individual specimens after exposure are summarized in Table II.

Cadmium plated steel, Figure 2, shows severe rusting of the 0.3 mil Cd plated steel (lower specimen, third row from left), whereas the 0.5 mil Cd plate (center) shows some surface darkening and general rusting and the 1.0 mil Cd plat (top) shows surface darkening with only very slight general corrosion. These control specimens are indications of a relatively mild exposure.
